A Goldilocks Solution: Restoring Road Access in the Most Geologically Unstable Area of Canada

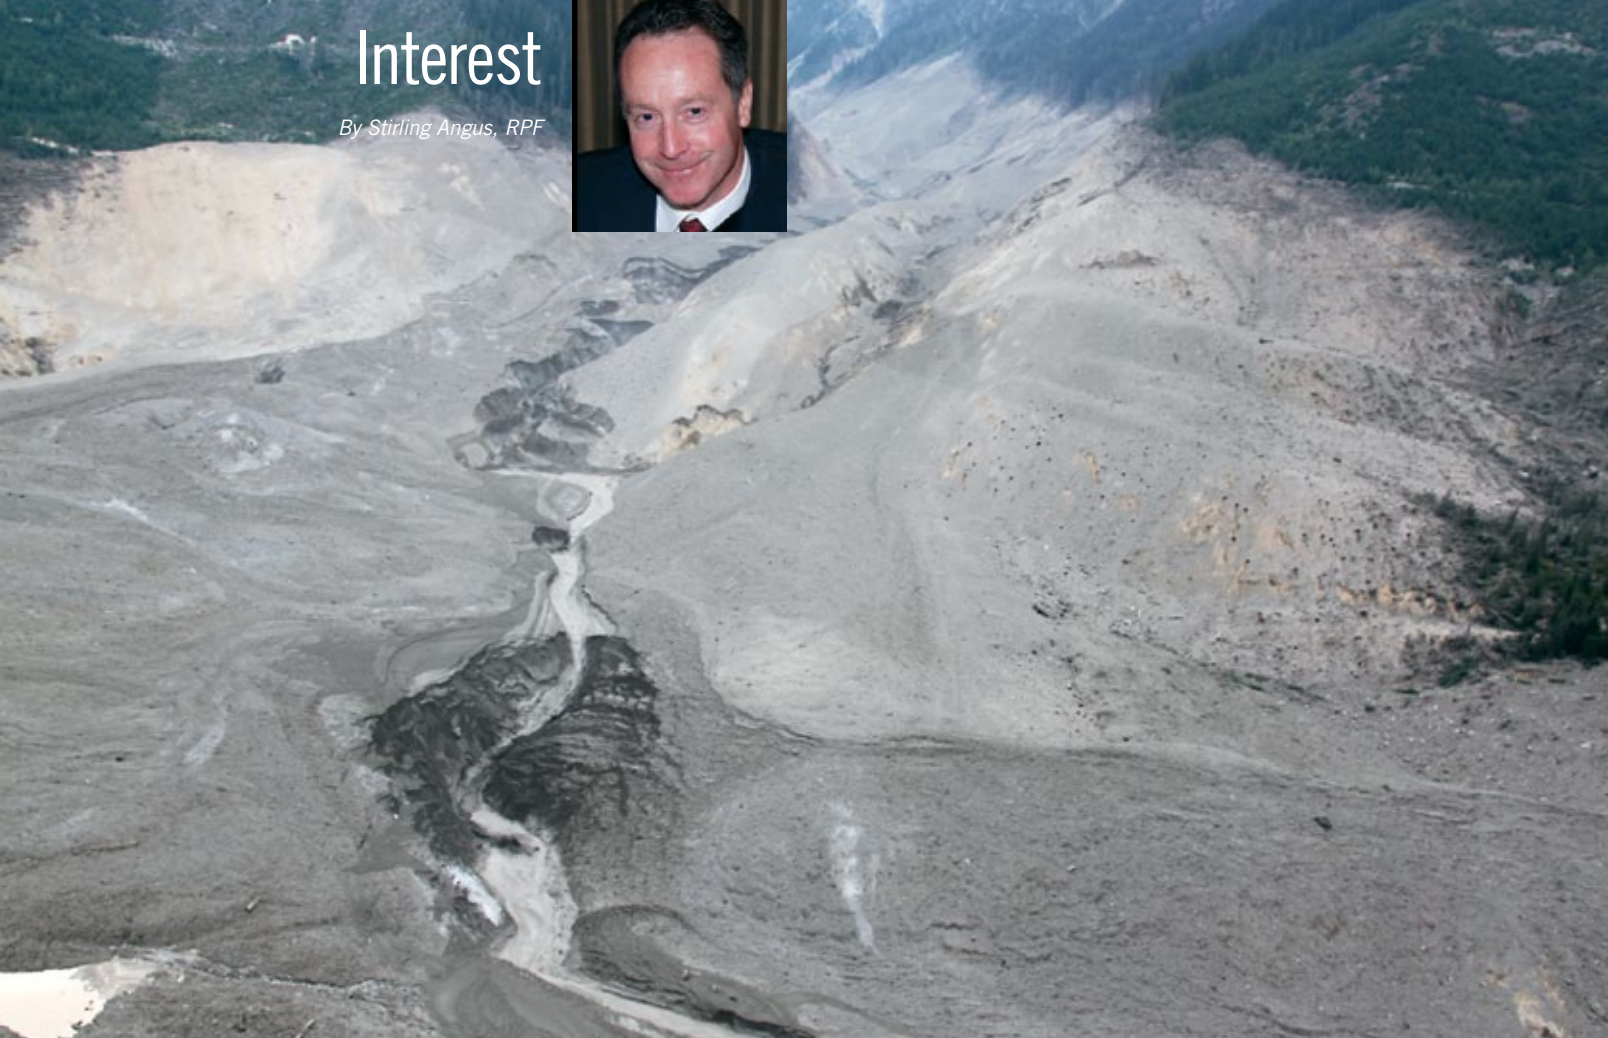
This landslide, the second largest in Canadian recorded history, obliterated five pieces of heavy equipment (not even a paint chip left) and destroyed several kilometres of road and access infrastructure.

The weather cooled and on August 5th we scheduled the crew to return for 7 am the next day. At 3:31 am, August 6, 2010, another slide came down and flowed through the worksite at an estimated 100 meters/second. It was through the area in a matter of seconds and was the second largest landslide in Canadian recorded history. Thankfully, no one was there. The slide obliterated

five pieces of heavy equipment (not even a paint chip left) and destroyed several kilometres of road and access infrastructure.

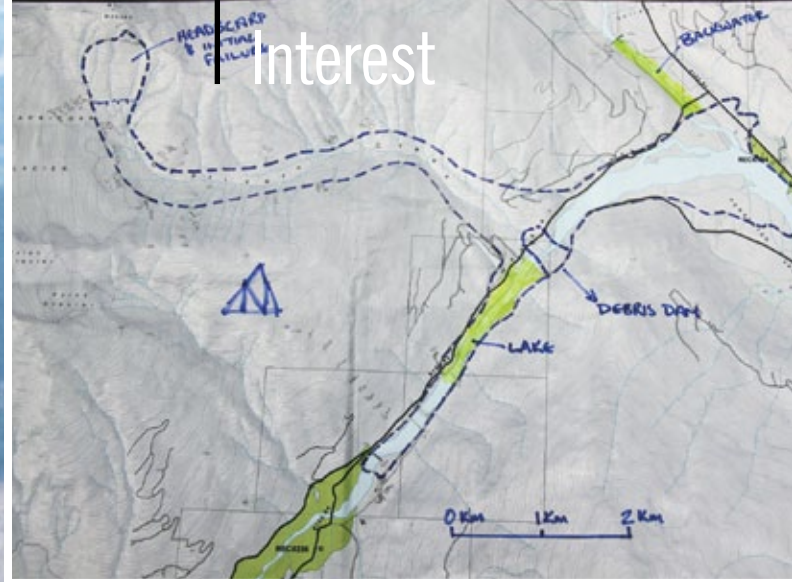
Looking down the Capricorn and Meager Creek valleys into the Lillooet River, this photo was taken 12 hours after the August 5th slide occurred.
